MICROBIAL EVALUATION REPORT  
FOR  
KEARNY TOWN HALL AND TEEN CENTER

ATLAS PROJECT NO. 1052000242, PHASE 13

REPORT DATE: April 16, 2024

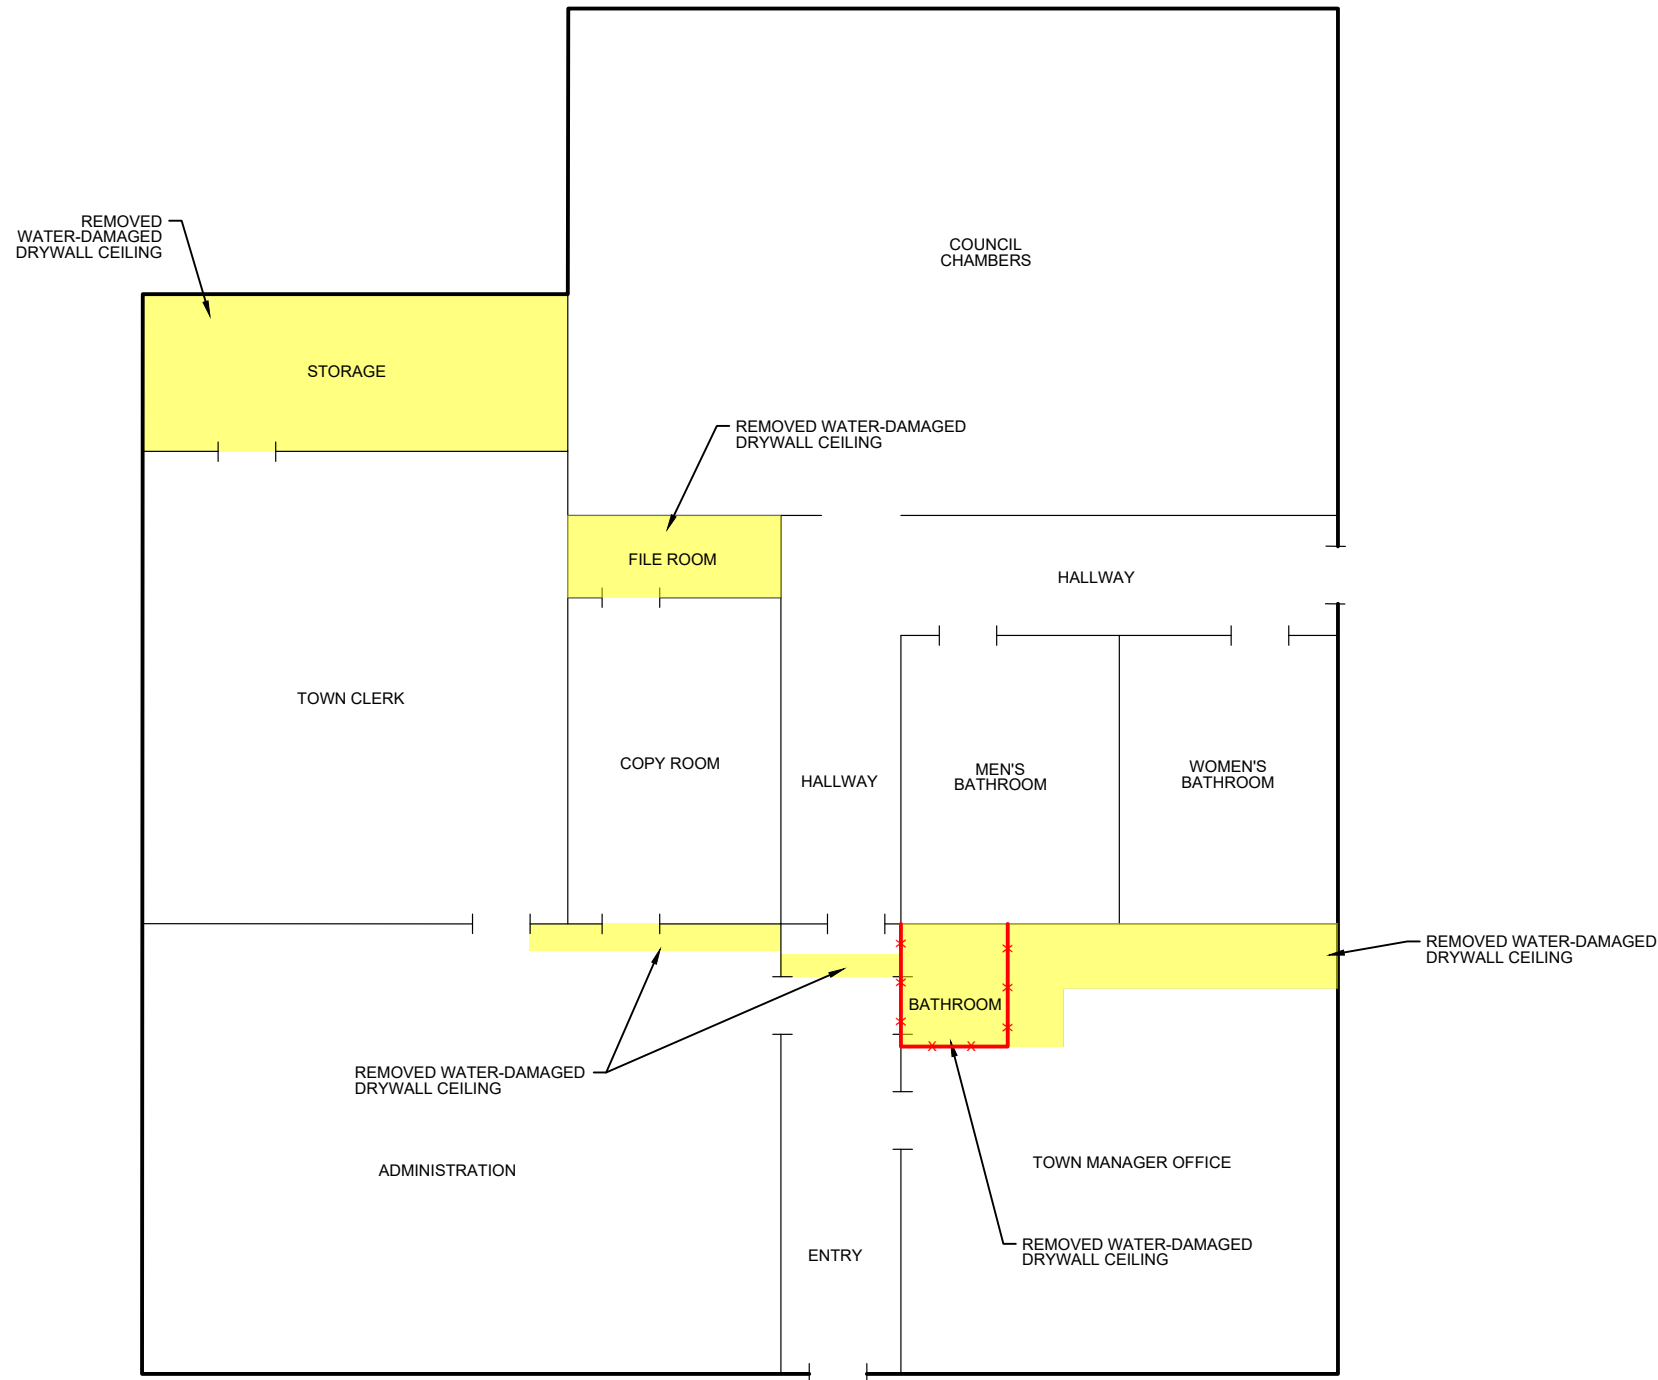
**WATER DAMAGE & SVMG LOCATION MAP  
VISUAL ASSESSMENT (TOWN HALL)**

In the Town Hall building, visual water-damaged material was located in the entry, bathroom, town manager's office, administrative area, copy/file room and storage area. In these areas, the drywall had been removed and the wall cavities were open. The remaining building materials did not have elevated moisture concentrations when tested with a penetrating moisture meter. SVMG was not present in the building. SVMG is tested by touching the suspect discoloured areas and determining if it is smearable. If the discoloration smears, it is considered SVMG. If it does not smear, it is considered discoloration from other non-microbial sources. None of the discoloration in this building was smearable and was not considered SVMG.

- Remove any visibly water damaged drywall systems, walls and ceilings. Check wall cavities for SVMG. If discoloration can be smeared, it is assumed to be microbial growth.

- Thoroughly clean and HEPA vacuum all open wall cavities.
  - Rebuild areas after a thorough cleaning of the entire building.
- Additional water damage/mold growth may be present in inaccessible areas such as pipe chases, wall cavities, etc. Adjacent areas should be visually examined during the microbial remediation activities.

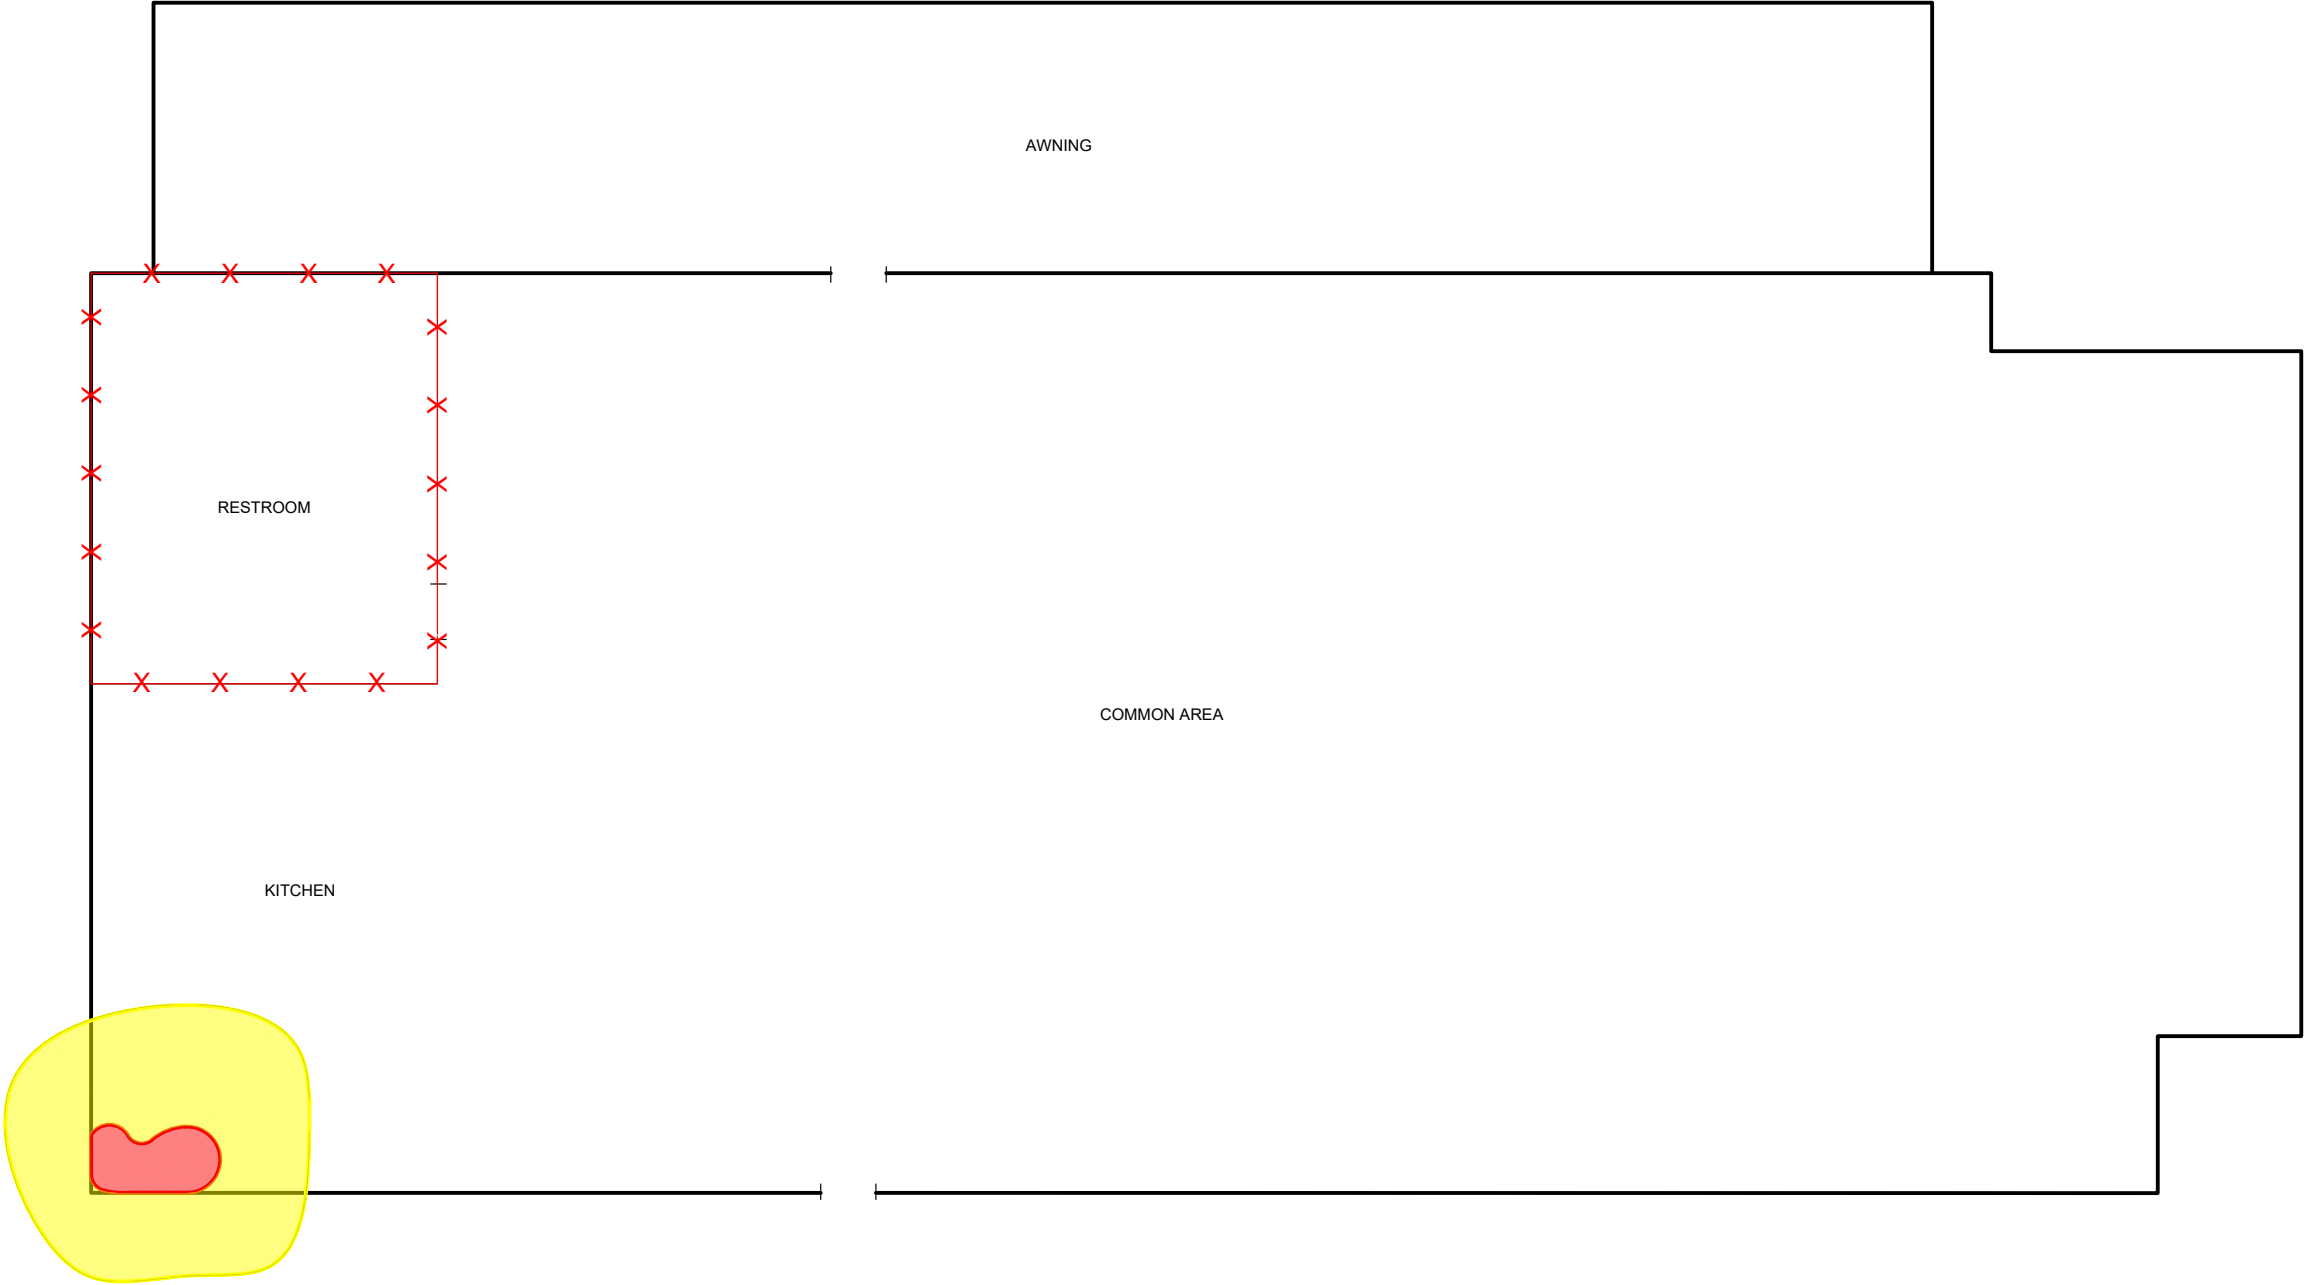
WATER DAMAGE & SVMG LOCATION MAP  
VISUAL ASSESSMENT (TEEN CENTER)  
TEEN CENTER  
912 (B & C) TILBURY DRIVE  
KEARNY, ARIZONA

In the Teen Center building, access to the drywall systems was limited due to wood panelling covering the walls and wood covering on the ceilings. Drywall was removed from all four walls of the restroom and the open wall cavities were visually examined. SVMG was present on the ceiling of the kitchen area, northwest corner. The SVMG was less than 10 square feet of growth and was located in an area of visible water damage.

- Kearny Teen Center
    - SVMG is present on the kitchen ceiling in the northwest corner. This area should be cleaned with an antimicrobial cleaner and building materials removed, if possible.

- Remove any visibly water damaged drywall systems, walls and ceilings. Check wall cavities for SVMG. If discoloration can be smeared, it is assumed to be microbial growth.
- Thoroughly clean and HEPA vacuum all open wall cavities.
- Rebuild areas after a thorough cleaning of the entire building.
- Upon request, and for an extra charge, Atlas may perform a post-remediation verification (PRV) survey following completion of remediation efforts in either or both buildings to include visual assessment and air sampling for airborne mold spores to determine effectiveness of remediation measures.

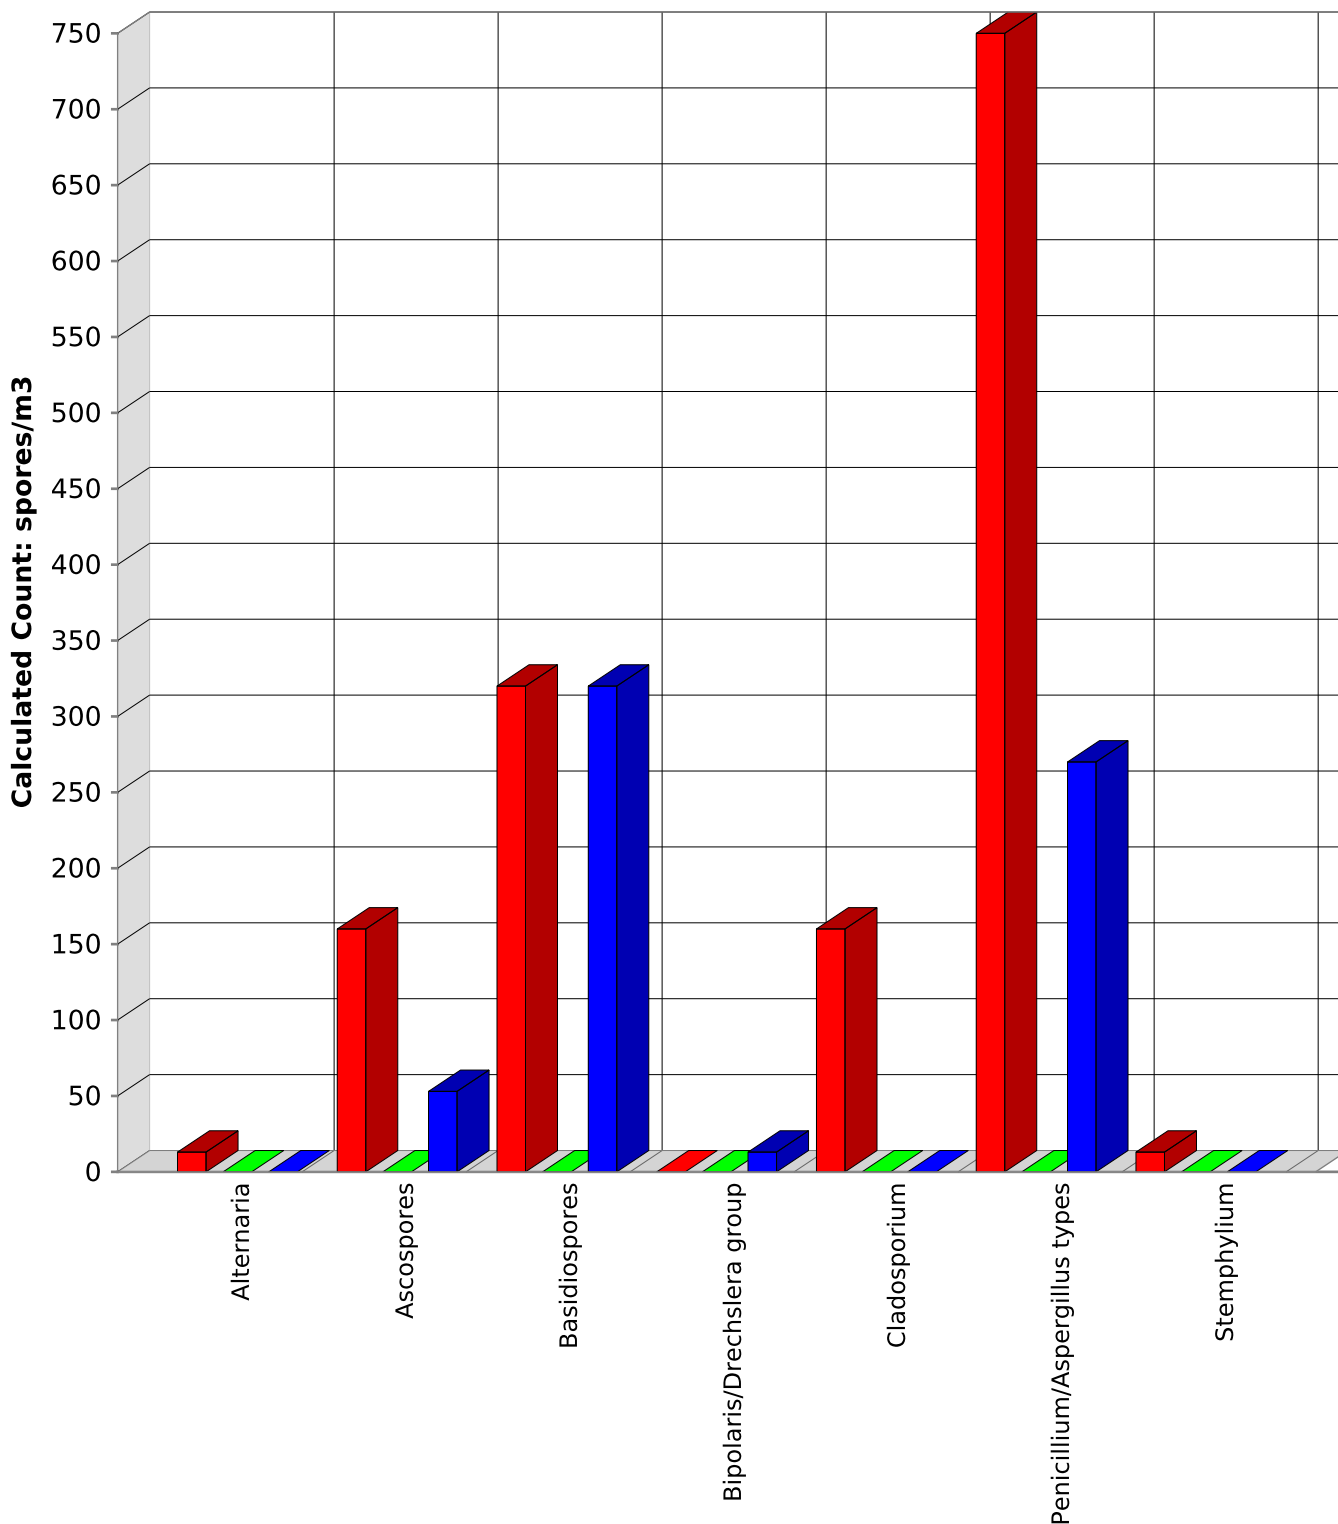
■ 022324-TH-1: Storage ■ 022324-TH-2: File Room (see comment A)  
■ 022324-TH-3: Entry bathroom

**Comments:** A) No spores detected.
