**ASBESTOS CONTAINING MATERIAL SURVEY REPORT  
OF  
KEARNY TOWN HALL AND TEEN CENTER**

**912 (B & C) TILBURY DRIVE  
KEARNY, PINAL COUNTY, ARIZONA 85137  
APN: 301-13-6340**

**ATLAS PROJECT NO. 1052000242, PHASE 13**

**REPORT DATE: APRIL 12, 2024**

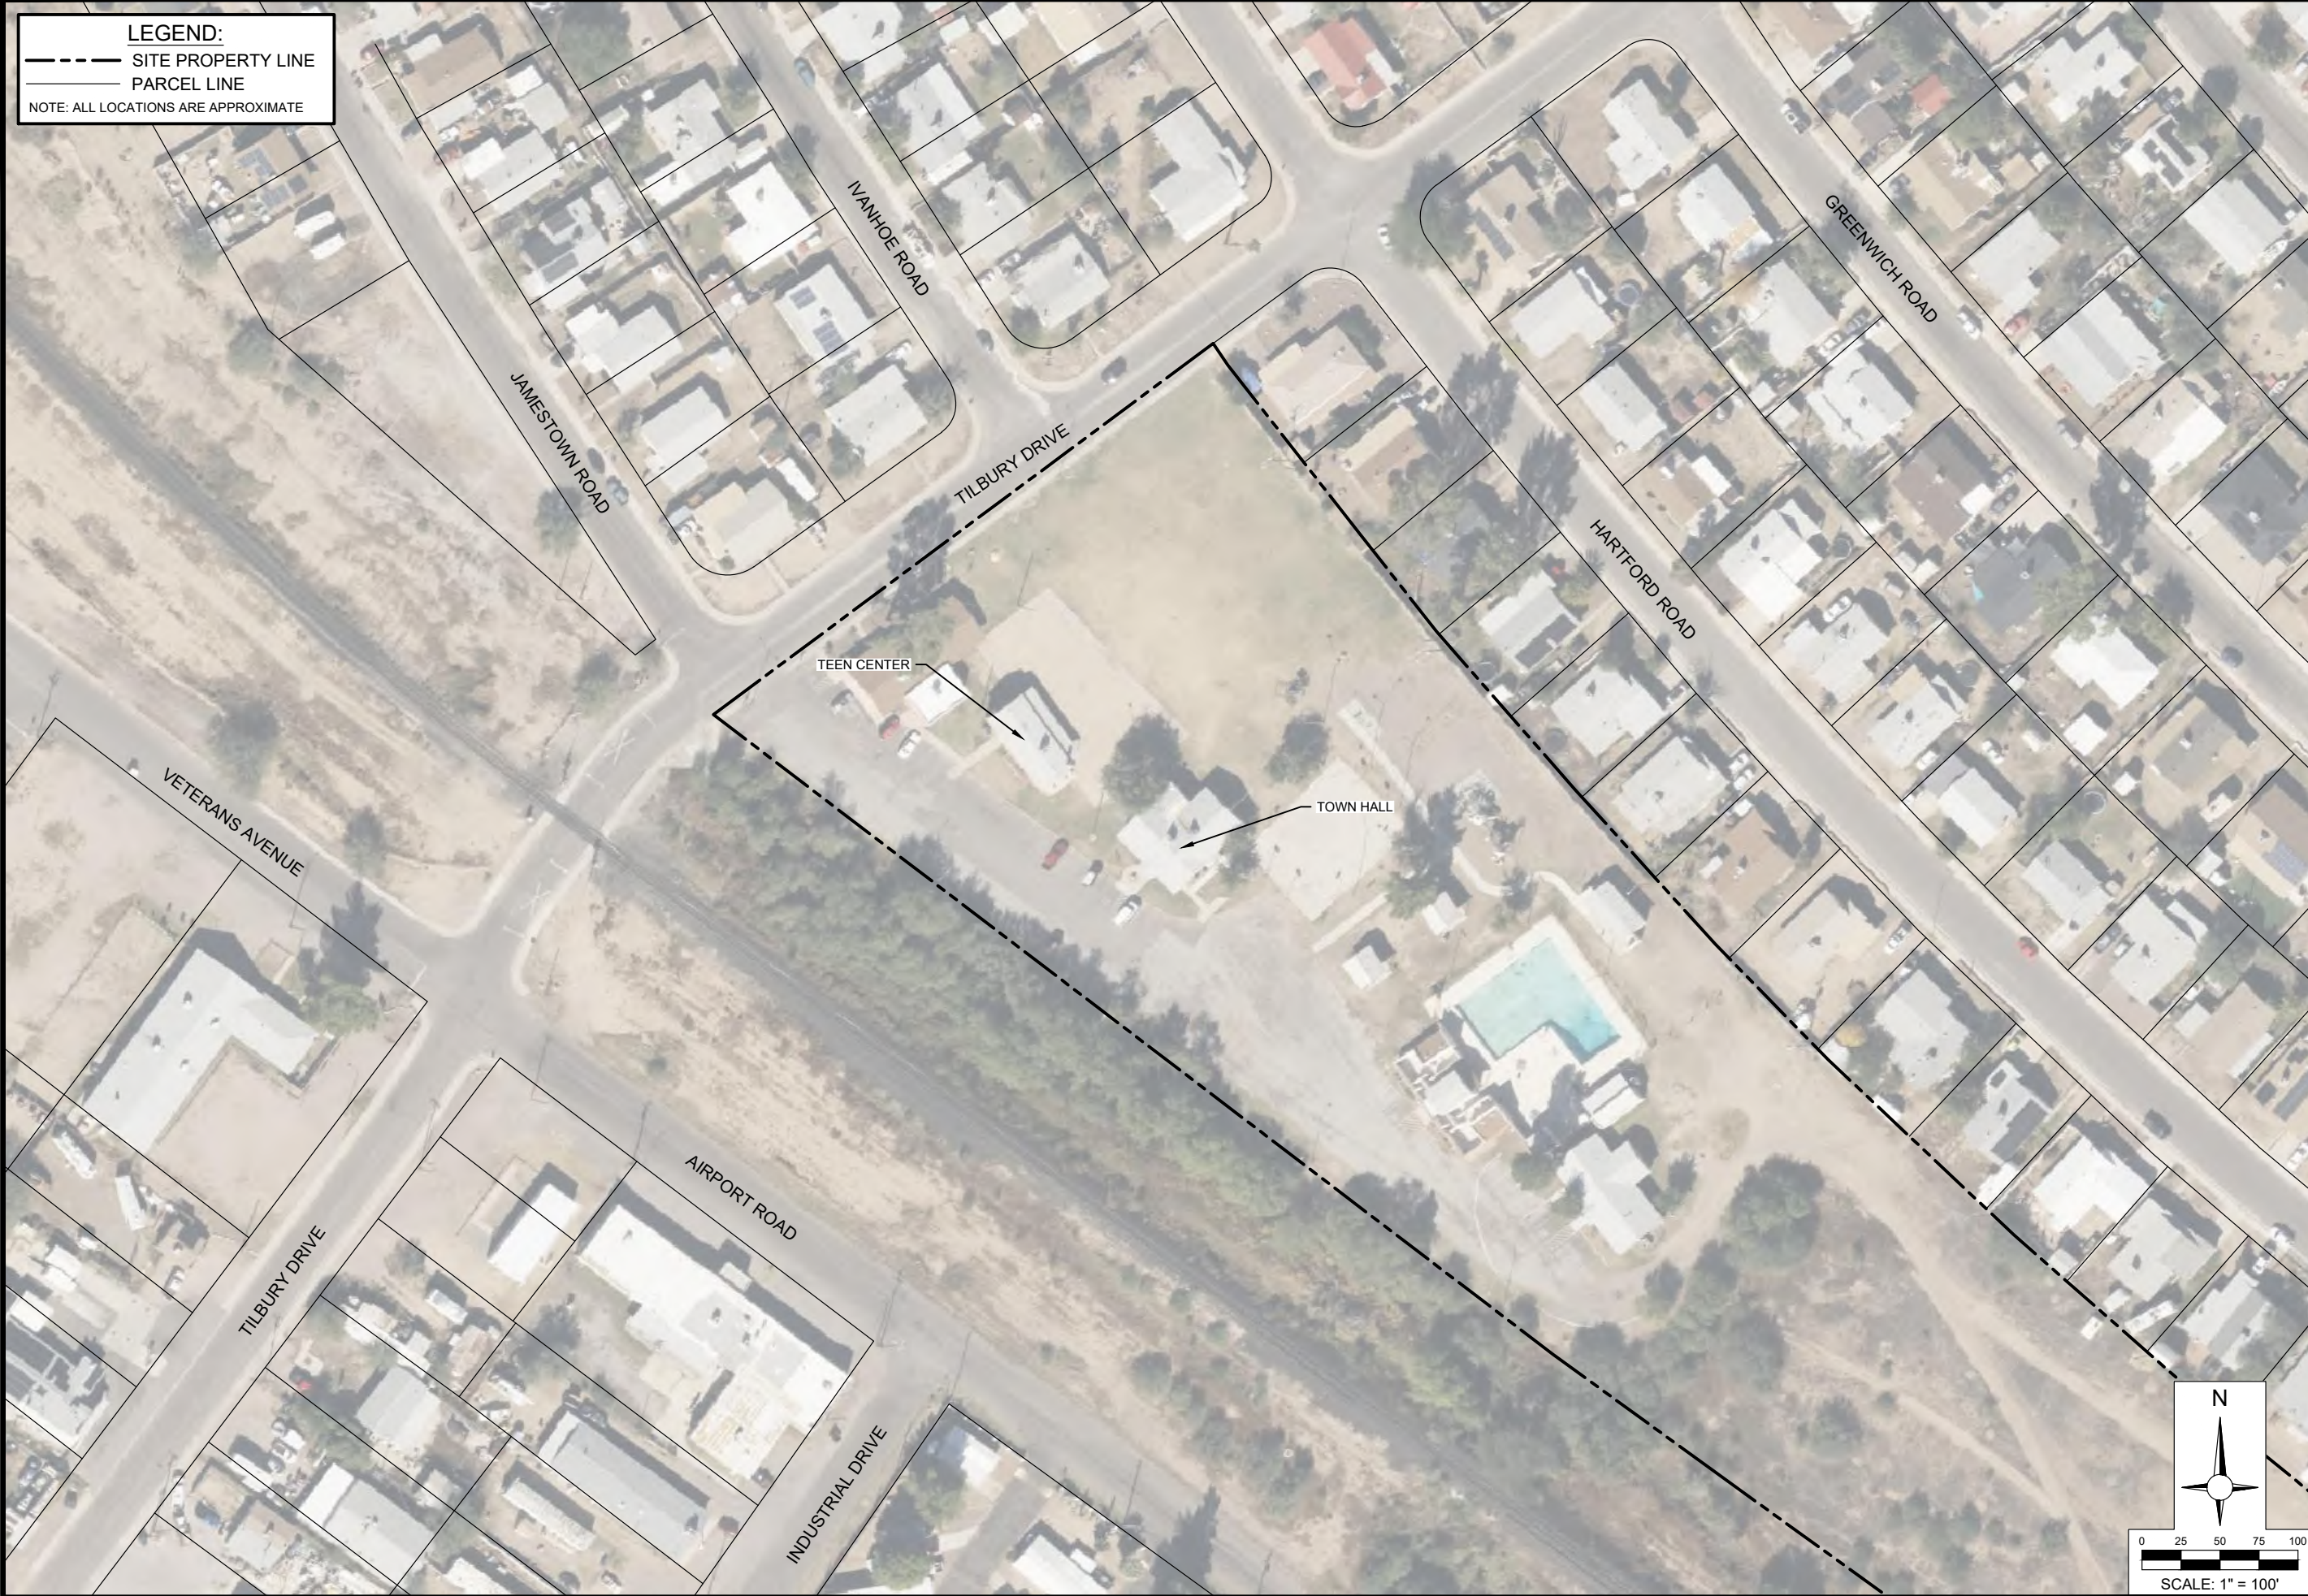
C:\USERS\MILES.SHARP\LESSON\ATLAS\DIGITAL SERVICES - FILE SERVER\2024\CAD DEPARTMENT\GILA COUNTY CONTRACTOR MANAGEMENT\KEARNY TOWN HALL & TEEN CENTER\1052000242-REG.DWG, FIG1

**LEGEND:**  
- - - SITE PROPERTY LINE  
— PARCEL LINE  
NOTE: ALL LOCATIONS ARE APPROXIMATE

N  
0 25 50 75 100  
SCALE: 1" = 100'
